Bridge in the Posterior Mandible

This healthy 71 year old female patient presented with an unrestorable right mandibular posterior four unit bridge, due to catastrophic fracture of the mesial retaining tooth 44.

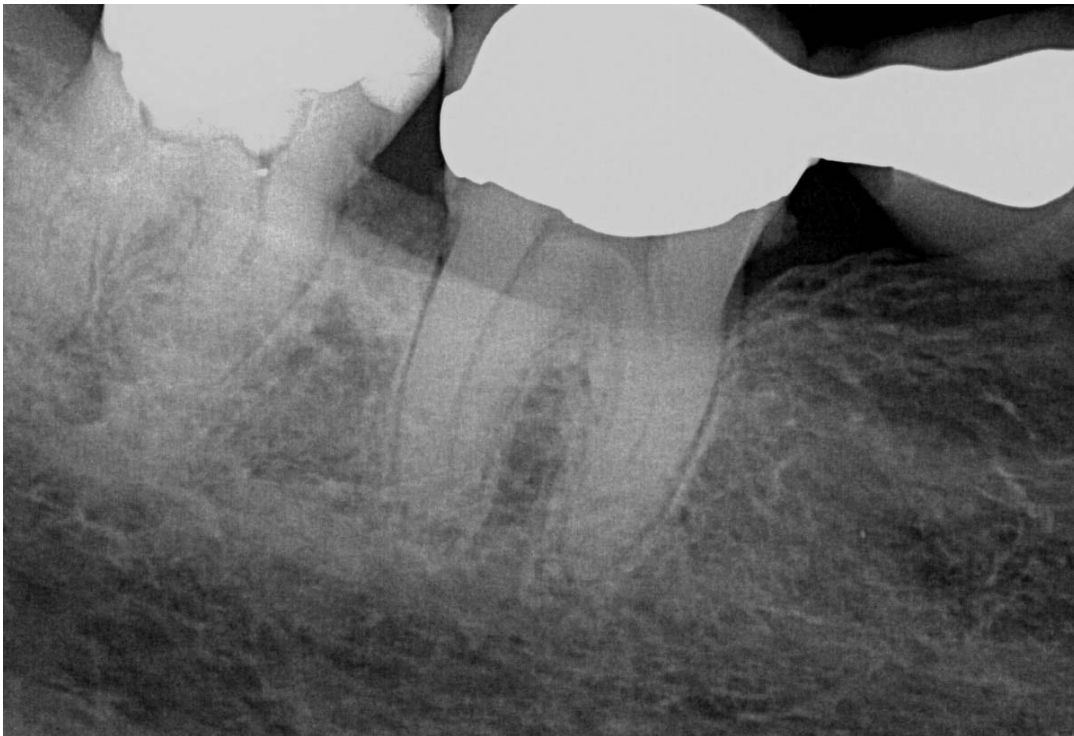
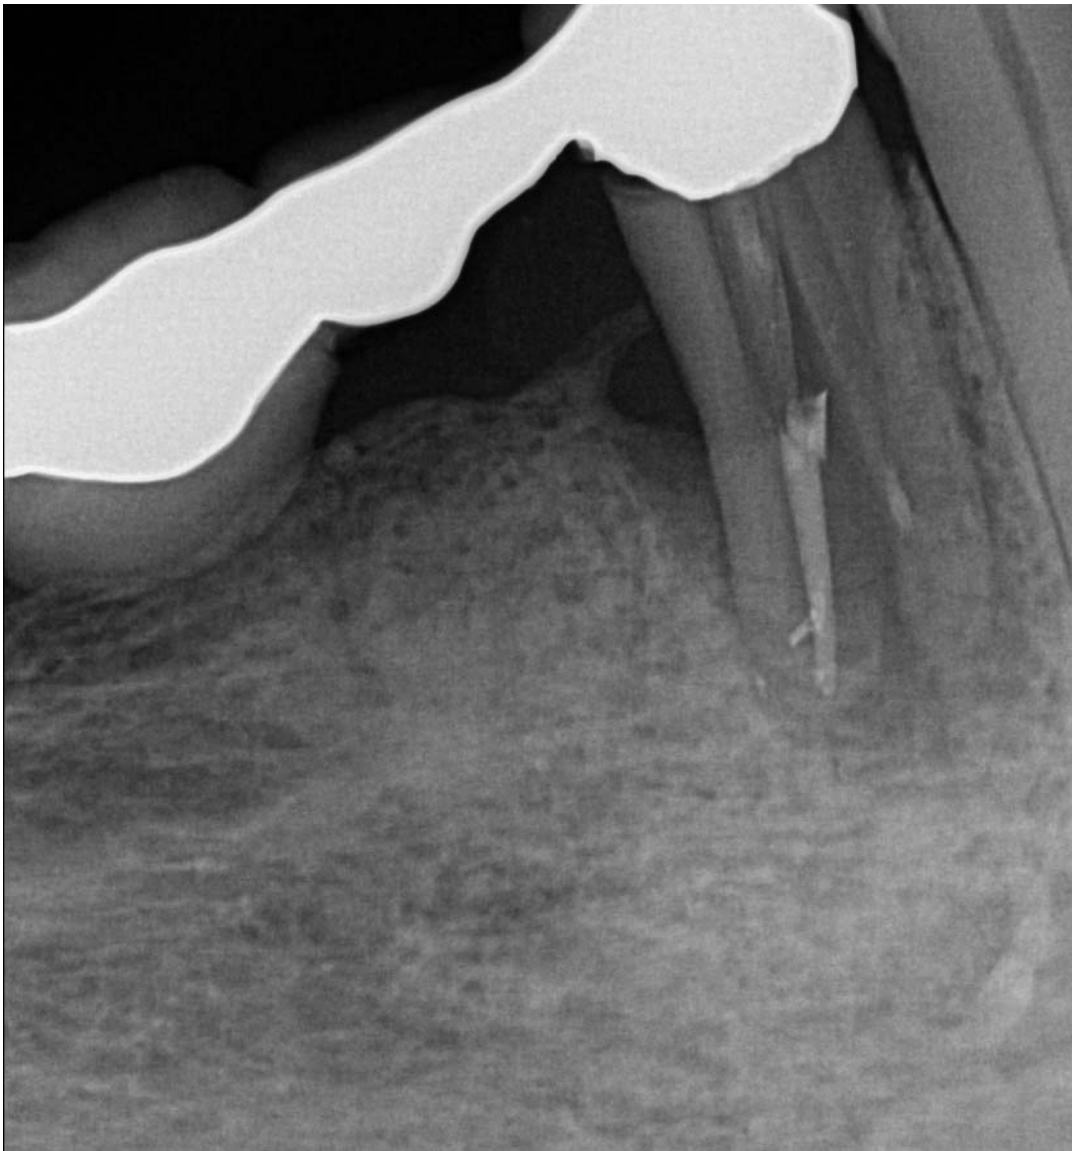
Diagnostic Pre-Treatment Images

Due to the extent of the infection, tooth 44 was extracted, the site carefully curetted, and then left to heal for three months prior to bone volume assessment with a cone beam tomograph (Soridex).

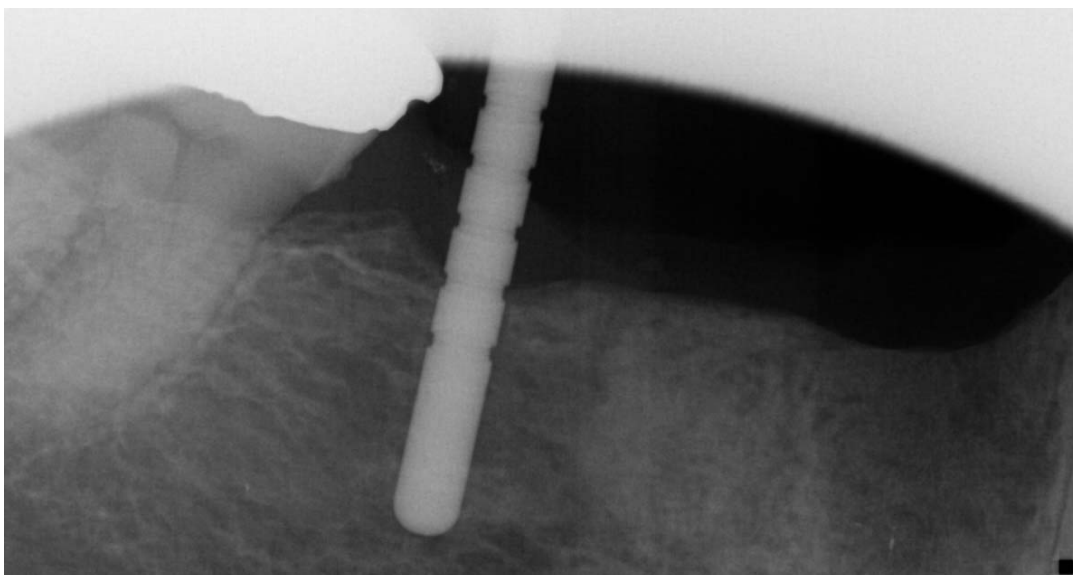
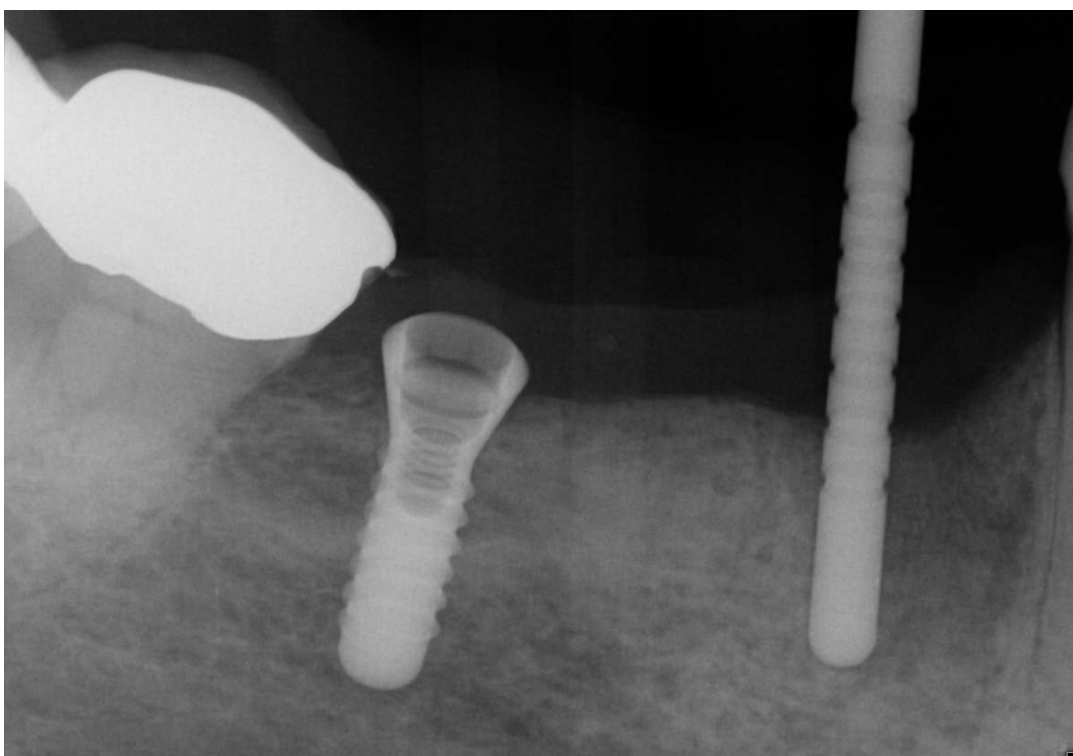
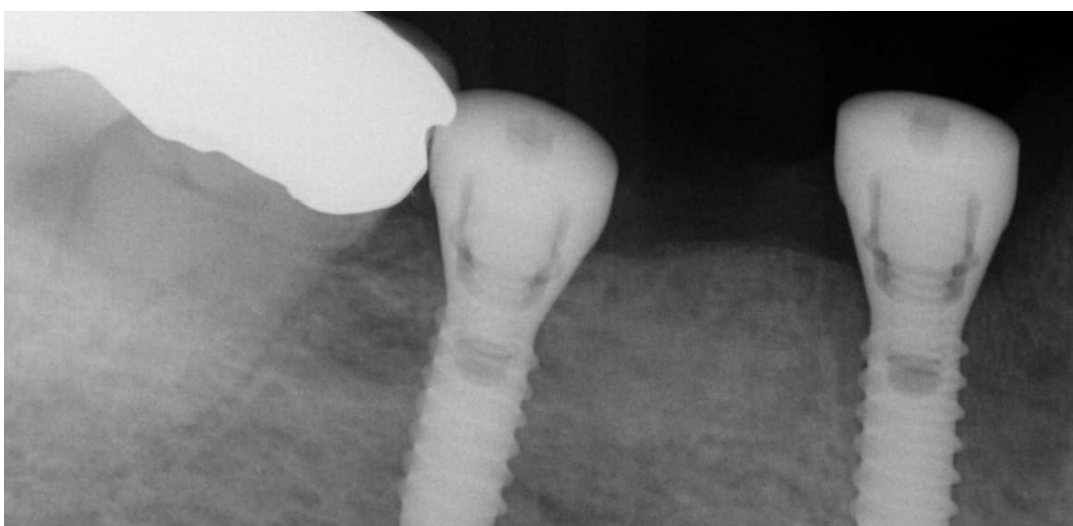
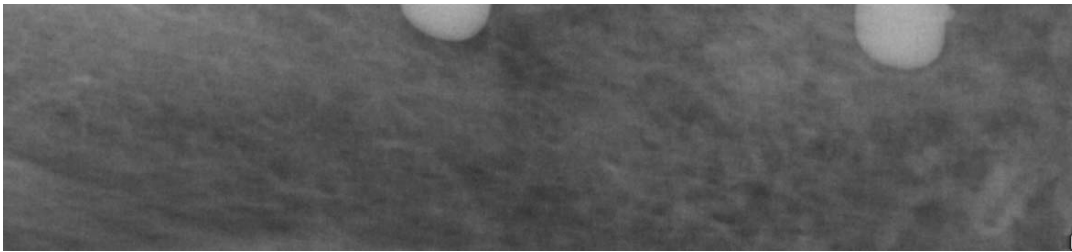
Treatment Images

Once healing and adequate bone volume above the mandibular canal had been confirmed, two Bioconcept 3.3mm x 10mm tissue level implants were placed in sites 44 and 46. Several careful progressive intraoperative periapical radiographs were taken to confirm vertical position relative to the mandibular canal. Both implants were then placed with a primary stability of over 30 Ncm as a one stage surgical procedure, and 2mm healing abutments were then secured.

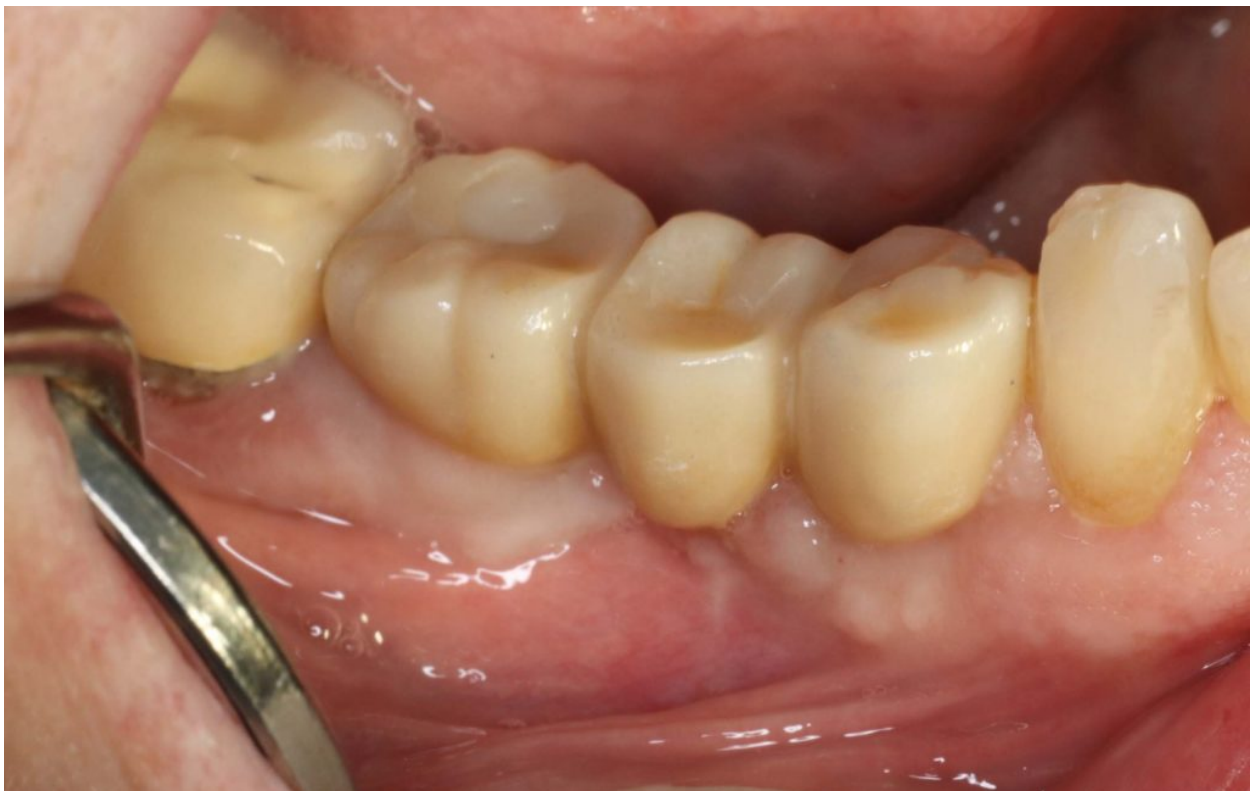
The definitive restoration was then inserted and checked for passivity of fit. The abutment screws were then definitively torqued to 35 Ncm. The access cavities were restored with PTFE tape and composite resin.
