Complete Maxillary Implant-Supported Bridge Case

- 4 March 5, 2020
- Dr Nicholas Hocking (https://nwhocking.com/author/nicknwhocking-com/)

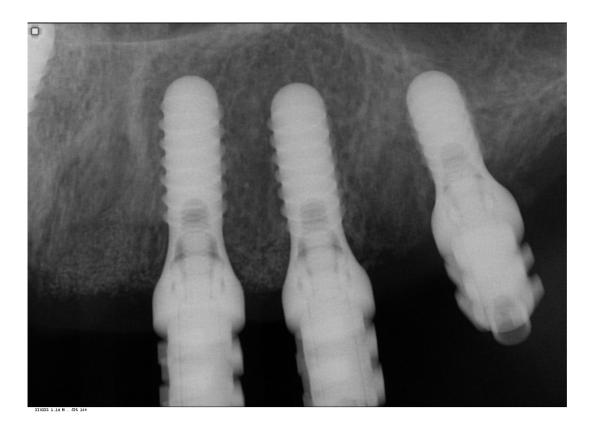
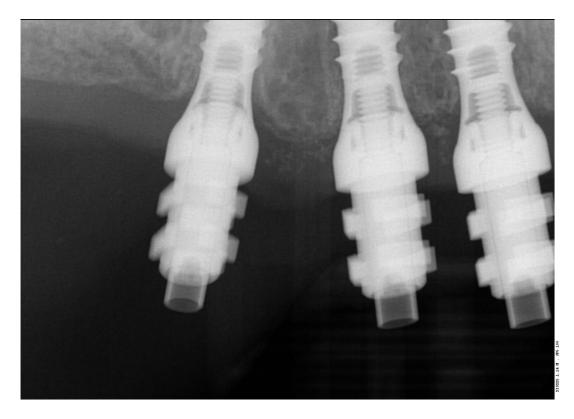
Multiple intra-operative radiographs were taken using depth gauges of gradually increasing diameter to ensure ideal positioning, particularly near vital structures such as the maxillary sinus.

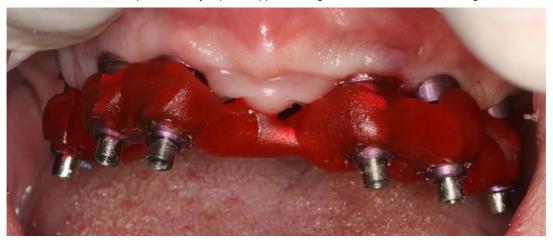
Following three months healing, definitive impressions were taken. Radiographs were taken to confirm complete seating of the impression copings prior to splinting of the impression copings and then impression taking.

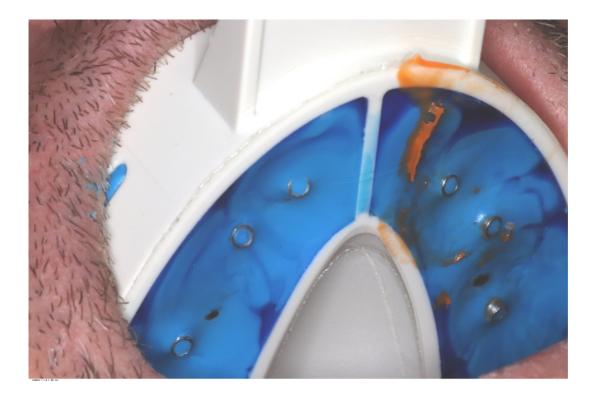
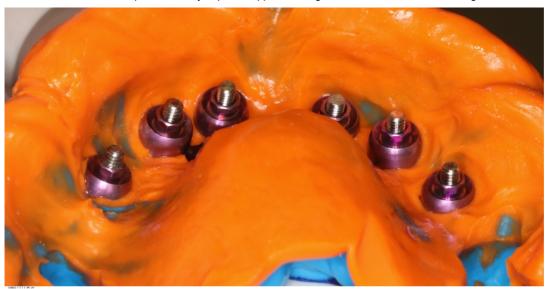
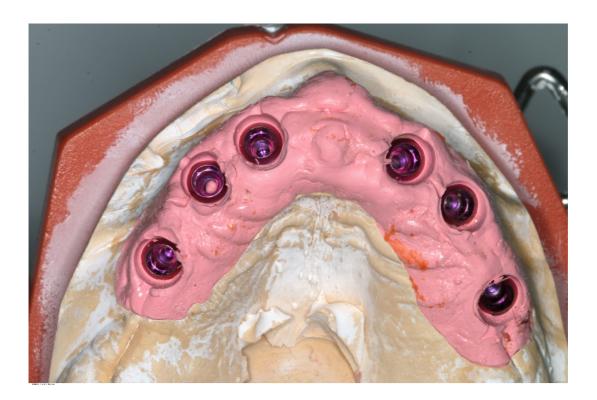
Impression copings were splinted together using metal wire and gradual incremental buildup with Fuji Pattern resin (GC Corp). Care was taken to avoid buildup of stresses in the resin leading to distortion in the impression.

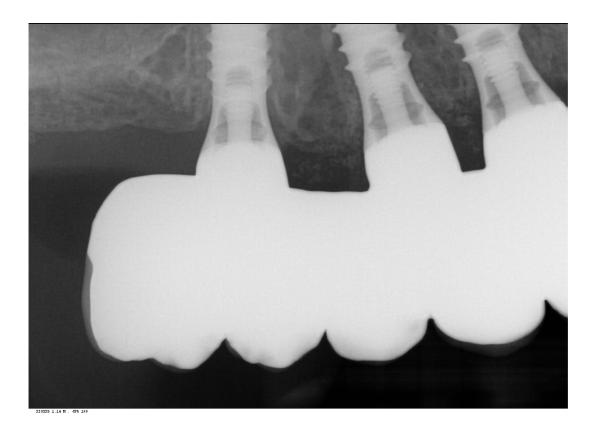
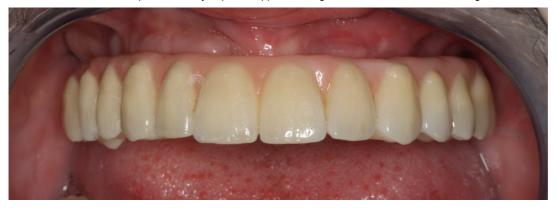
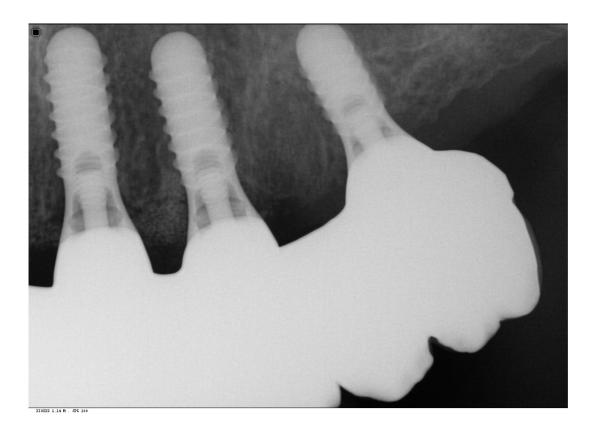
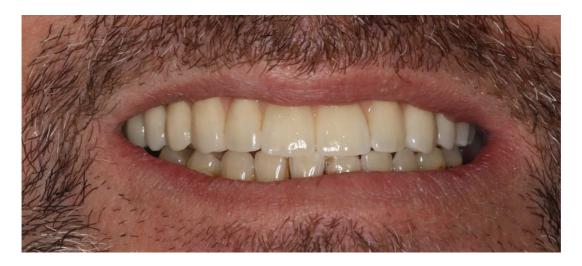
Records stage: due to the fact that all records were gained by the adjustment and confirmation of the provisional removable complete maxillary denture, records were quite straightforward. The complete denture was copied, flanges were removed, and the resulting guide was then seated over the existing tissue level healing abutments. A PMMA bridge with plastic inserts was constructed digitally in the laboratory and sent for final confirmation prior to construction of the definitive porcelain-fused-to-zirconia bridge.

The definitive bridge was inserted and radiographs were taken to confirm full seating and correct emergence profile. Once passivity of fit was confirmed, abutments crews were torque to 35 Ncm, and the access cavities were restored with PTFe tape and

composite resin. The occlusion was adjusted to ensure guiding services were smooth, concave, and gradually increasing pre-truce in steepness, and smooth shared group function in lateral excursion.
