The Aesthetic Zone

Below is a typical example of a young female with agenesis of her maxillary (upper) lateral incisors. This means they did not develop from birth.

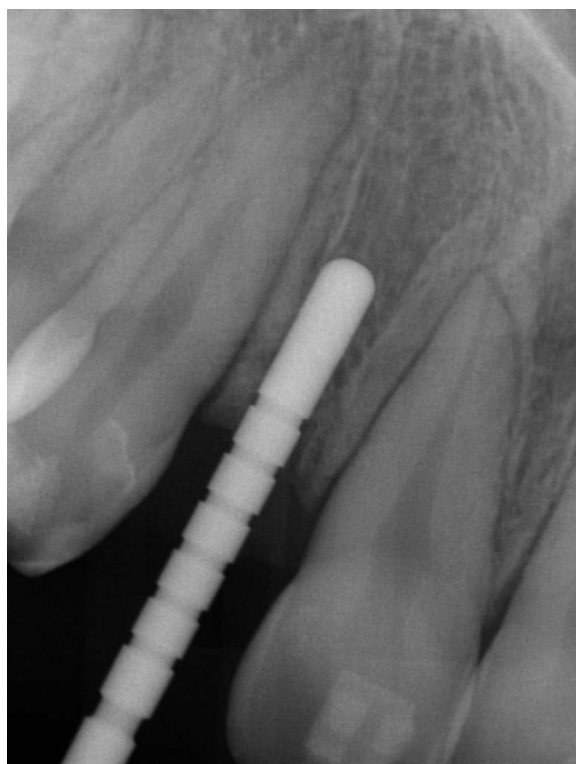
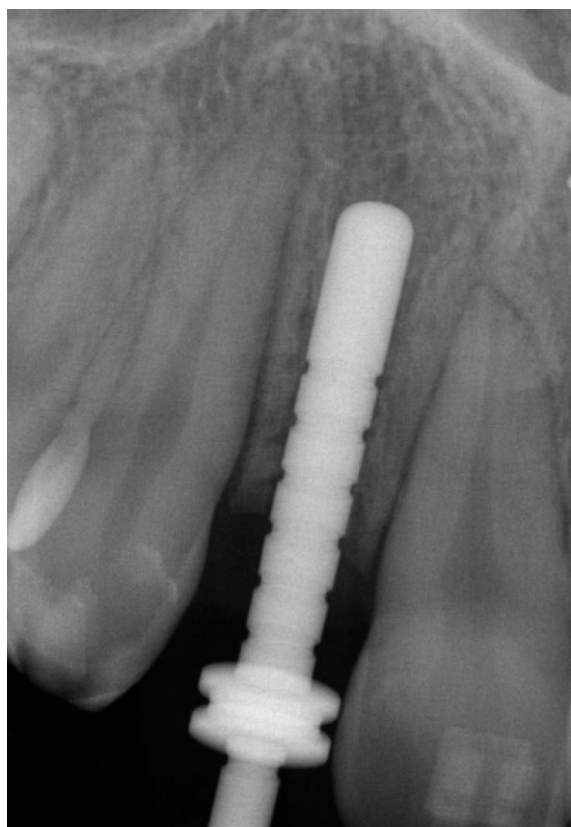
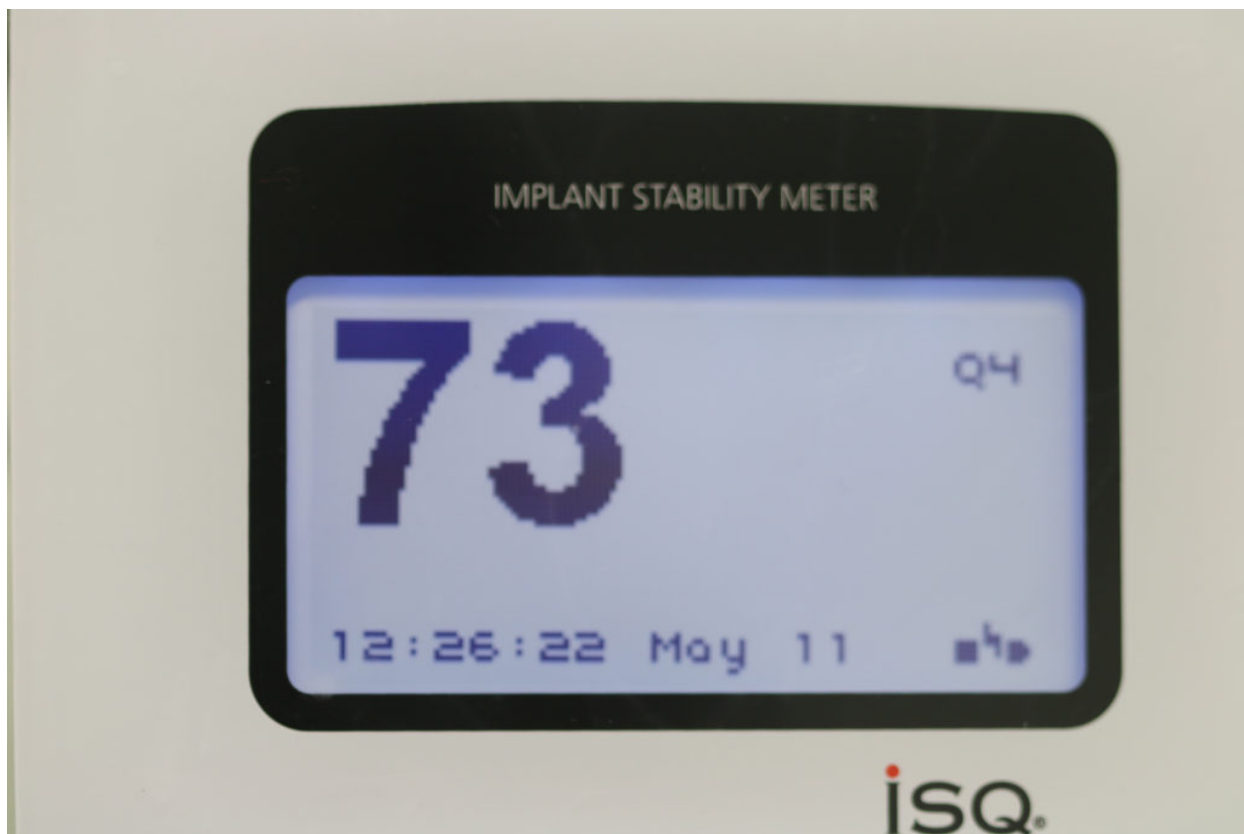
Two Bioconcept bone level RC 3.3mm implants were then carefully placed using a surgical guide to ensure ideal placement in this con ned space. Several intra-operative check x-rays were taken with depth gauges in place.

Successful osseointegration was confirmed with radiographs, and an ISQ (Ostell) reading of greater than 64.

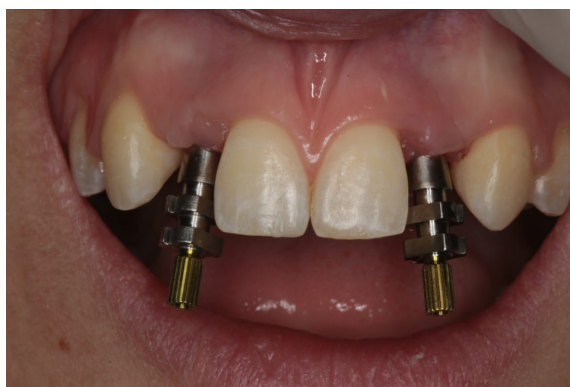
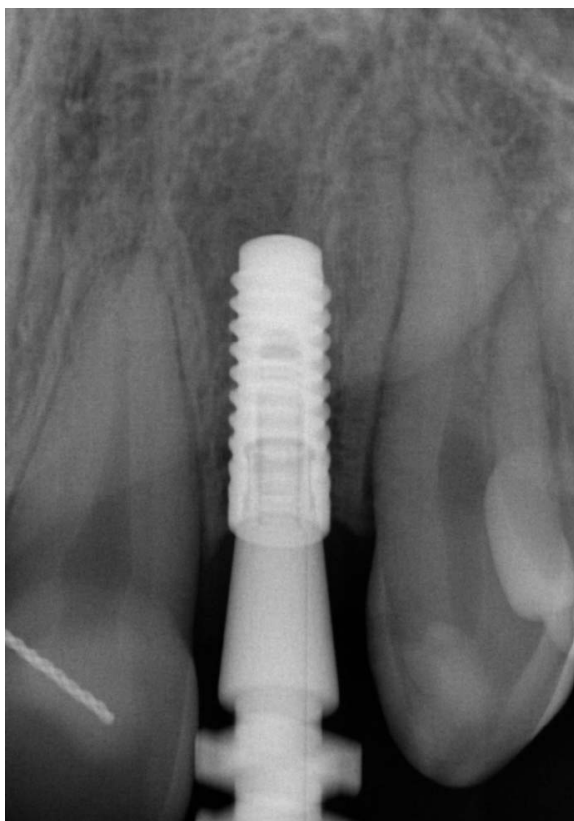
The definitive impression is now taken. Impression copings are placed and a check radiograph is taken to confirm complete seating.

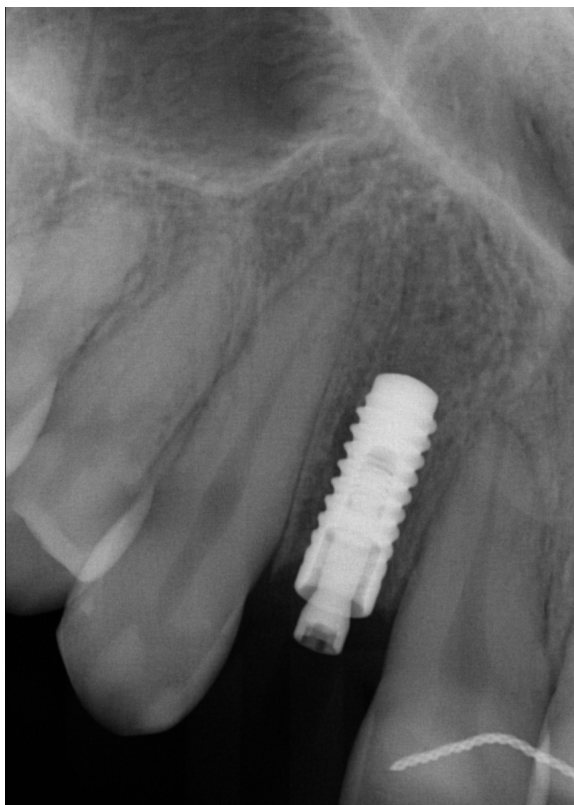
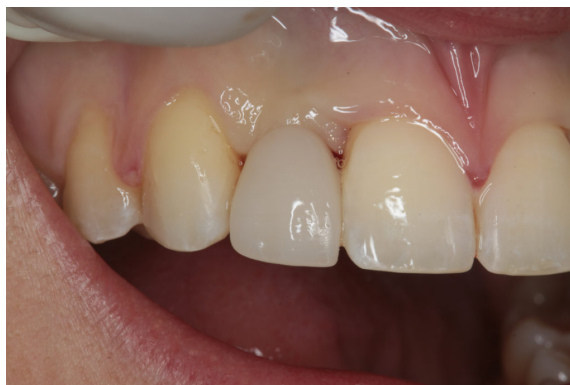
Initially provisional restorations were constructed. This is to confirm the ideal emergence profile and to support complete healing of the interproximal papillae.

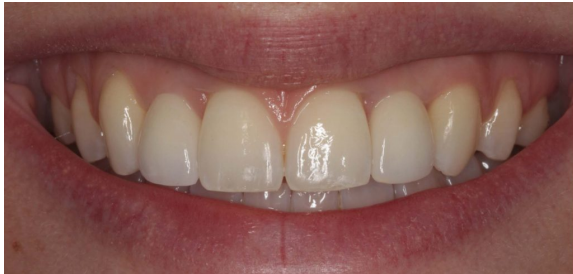
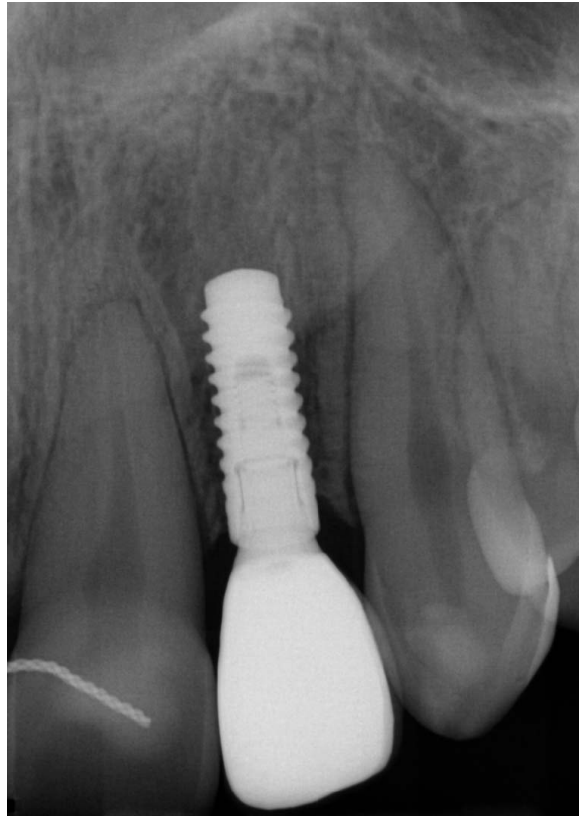
Review

Following two months with provisional restoration in place, aesthetics were deemed to be ideal.

Impression copings were then customised to capture the emergence profile which had been established, and definitive impressions were taken. Veneered zirconia crowns were then luted onto Variobase abutments in the lab, and the restorations were then inserted, and abutment screws torqued to 35 Ncm.
